Relates to: R2682N, R2384N

Fitted to: TOYOTA HILUX KUN26 3.0ltr Diesel Turbo

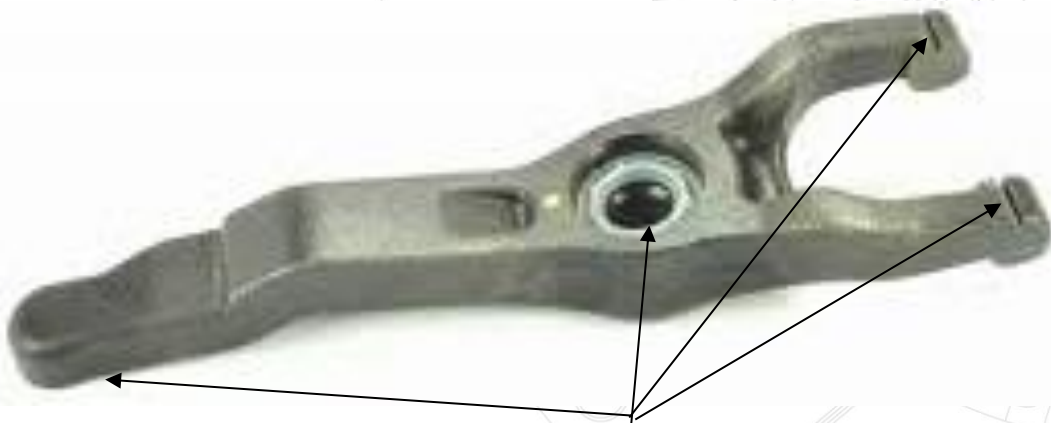
In some applications CI have observed that if there is insufficient or no lubrication on the clutch release fork and pivot ball causing a noise to come from the bellhousing. This noise has often been associated with the thrust bearing or clutch plate.

Lubricate these areas.

1. When the gearbox is apart the clutch release fork can be removed and thoroughly cleaned, using a degreaser or alike.
2. Lubricate the areas pointed out in the image of the clutch pivot fork below.
3. Check the pivot ball for wear. If there is any evidence of wear the pivot fork will need to be replaced.
4. Lubricate the bearing and check that it slides satisfactorily on the spigot shaft.
5. Refit the clutch release fork, making sure the clip has been located and fork sits on the pivot ball.
6. Fit the new clutch bearing to the release fork - making sure the bearing is secured correctly and the fork is in the correct position.
